Implementation of Reducing Machine Downtime on Eco-Automotive Component Products Using the Quality Tools Approach

Hikari Nurhadi^{a,*}, Desy Agustin^a, Fadhil Nurhadi^a, Feby Dendra^b

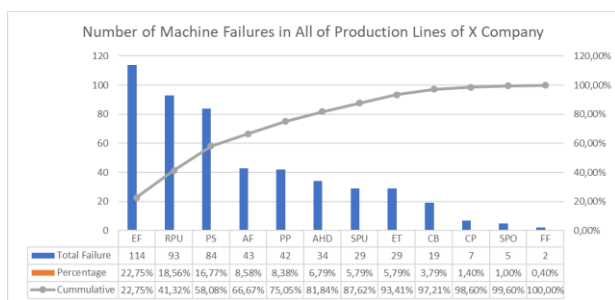
Fig. 2. Number of Machine Failures in All of PT X Production Lines.

Figure 2 illustrates the data processing results related to the number of damages across all production lines at PT X based on Pareto analysis conducted over three months. This data encompasses various types of damages and their frequencies, sorted to highlight those occurring most frequently and significantly impacting productivity. Thus, this figure provides a comprehensive view of areas needing more attention for improvement. The findings of this analysis are expected to serve as a reference for decision-making efforts aimed at enhancing operational productivity at PT X.

The results of the first iteration of the Pareto diagram indicate that the highest number of damages at PT X occurred on the EF (eco-filter) line, with 114 instances of damage. This line is followed by RPU with 93 instances of damage and PS with 84 instances of damage. Other lines experienced machine damages totaling no more than 50 instances. From this analysis, it is clear that improvement efforts should focus on the 20% of occurrences that have the greatest impact on productivity, specifically on the EF line, which accounts for 22.75% of the occurrences.

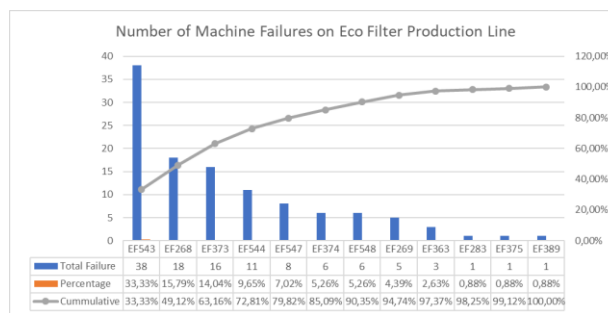
Fig. 3. Number of Machine Failures on EF Production Line.

The results of this second iteration are depicted in Figure 3, illustrating the types of machines with the highest frequency of damage. This analysis provides further insight into the primary causes of damage and assists in prioritizing specific repair needs on the EF line. This approach aims to enhance operational efficiency and significantly reduce machine downtime.

From 114 instances of damage on the EF line, it was found that machine EF543 had the highest number of damages, totaling 38 occurrences over three months, accounting for 33.33% of the total. This analysis indicates that machine EF543 is the primary source of issues on the EF line and requires special attention in improvement efforts.

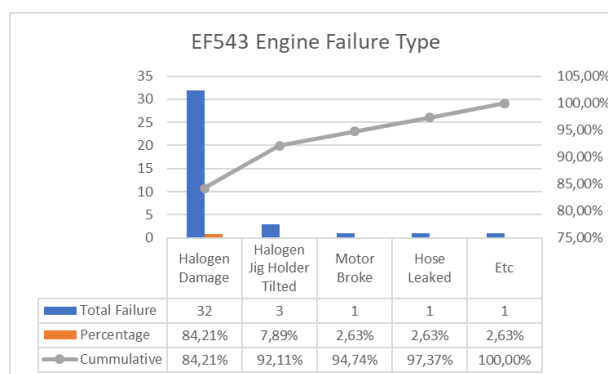
Fig. 4. EF543 of Machine Failure.

The results of this analysis are presented in Figure 4, providing a visual overview of the distribution and characteristics of failures on machine EF543. By understanding the patterns and specific causes of damage, more effective and targeted repair strategies can be formulated, aiming to reduce the frequency of damages and enhance overall operational performance.

The final iteration involved identifying the source of damage on machine EF543 in the eco-filter line, revealing that more than half or nearly all of the damages on the machine were caused by halogen damage, occurring 32 times over a three-month period.

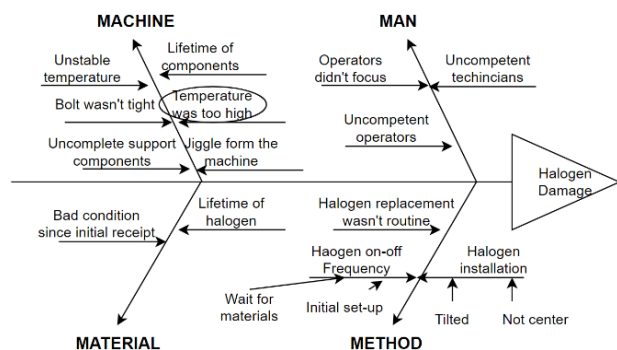
Fig. 5. Cause and Effect Diagram for Halogen Damage.

From the detailed analysis, it was found that the primary cause of halogen damage is excessively high temperature, exceeding the machine's power capacity. This information is detailed and clearly presented in Figure 5, depicting the cause-and-effect relationship between high temperature and halogen damage. These findings provide deep insights into various factors contributing to operational issues on the production line, serving as a crucial basis for designing effective and timely repair strategies.

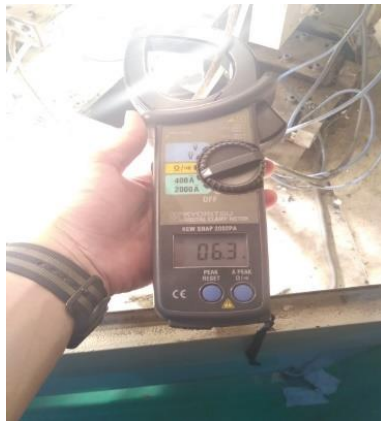
Fig. 6. Current Conditions Supplied to EF543 Machine.

Based on field observations, the maximum current required should only be 5.6 amperes, but the power supplied to the halogen reaches 6.3 amperes, as illustrated in Figure 6. This condition clearly exceeds the machine's standard capacity, resulting in halogen damage occurring 32 times over three months on the EF543 machine.

These findings indicate that the discrepancy between the required current and the supplied power is the main cause of the problem, which needs immediate addressing to minimize damage and machine downtime, potentially disrupting operational efficiency.

Field observations found that the current supplied to the machine exceeds the recommended specifications. Ideally, the machine should handle up to 3326 watts, but the actual specification only requires 3000 watts. This mismatch is a major factor causing repeated halogen damage, noted 32 times over three months on the EF543 machine.

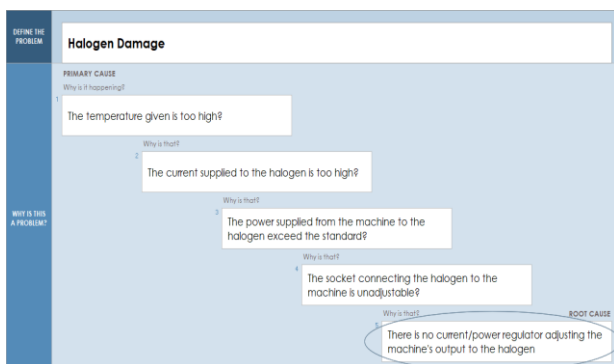
Fig. 7. 5 Why Analysis of Halogen Damage on EF543 Machine.

To overcome this challenge, thorough improvements are needed to regulate the supplied current to match the actual power required by the machine. As an analysis method, the 5 Why approach depicted in Figure 7 was used. This approach helps identify the root cause of the problem with repetitive questions leading to deeper causes related to factors impacting this current mismatch.

One technical solution that can be implemented is to modify the machine by installing a Thyristor Voltage Regulator (TVR). The TVR can be set to control the electrical current delivered to the machine according to the power requirements matching the specifications. By optimizing current settings through the TVR, is expected to reduce the risk of overheating and component damage to the halogen. This will not only increase the productivity

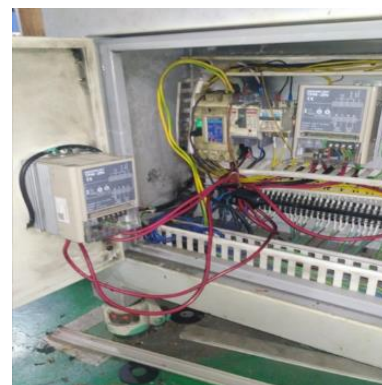
Fig. 8. TVR Installation Implementation on EF543 Machine.

The TVR installation on the EF543 machine can be seen in Figure 8. This step not only improves power flow regulation to reduce the load on the halogen but also increases overall energy efficiency. Using this technology is expected to optimize machine performance and reduce the risk of damage caused by unstable electrical currents. Additionally, TVR usage can increase equipment lifespan and reduce unexpected machine downtime, which in turn will boost productivity and operational reliability in a dynamic industrial environment.

The previous analysis revealed that the supplied current was too large, and inconsistent with the machine's capacity, causing a high frequency of halogen replacements. To address this issue, the machine was modified by installing a Thyristor Voltage Regulator (TVR). The TVR allows power flow regulation by adjusting the voltage amplitude and phase angle, with adjustable longitudinal-transversal regulation.

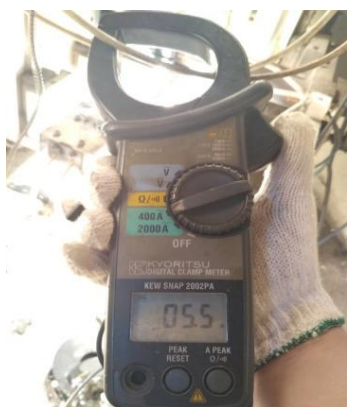
Fig. 9. Current Supply Regulation Results Using TVR.

Figure 9 illustrates the results of TVR installation on the EF543 machine, showing the ability to regulate the current generated by the machine according to operational needs.

The TVR installation on the machine has been successfully implemented and demonstrated the ability to regulate the current according to the machine's required specifications. The next step is to monitor the results of the performed improvements.
